Federal Pacific Electric

Douglas Hansen & Redwood Kardon

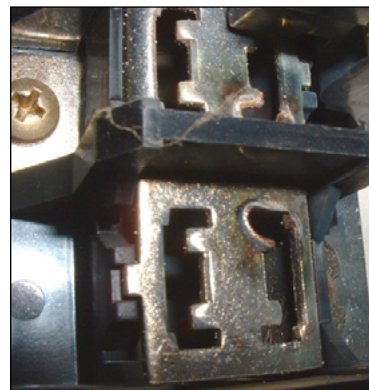
Figure 4 - Aluminum Sockets

Early FPE equipment had copper bus bars with the sockets cleanly defined (figure 3). Later FPE equipment used plated aluminum, which appears to have been stamped (figure 4). Some edges of the socket opening are slightly bent on these later models, further reducing the contact area of the breaker to bus connection.

Damage such as seen in figure 4 is quite common, though it cannot be seen until the breakers have been removed.
